STAFF SUBMITTAL

Application for Stream Channel Alteration Permit for
Streambank Protection and Stabilization
Riverside apartments, 333 Ohai Street, Wailuku River
Hilo, Hawaii, TMK: (3) 2-6-003:009

Application for Stream Channel Alteration Permit (SCAP.2868.8) for Streambank Protection and Stabilization, Riverside Apartments, 333 Ohai Street, Wailuku River in Hilo, Hawaii at TMK: (3) 2-6-003:009.

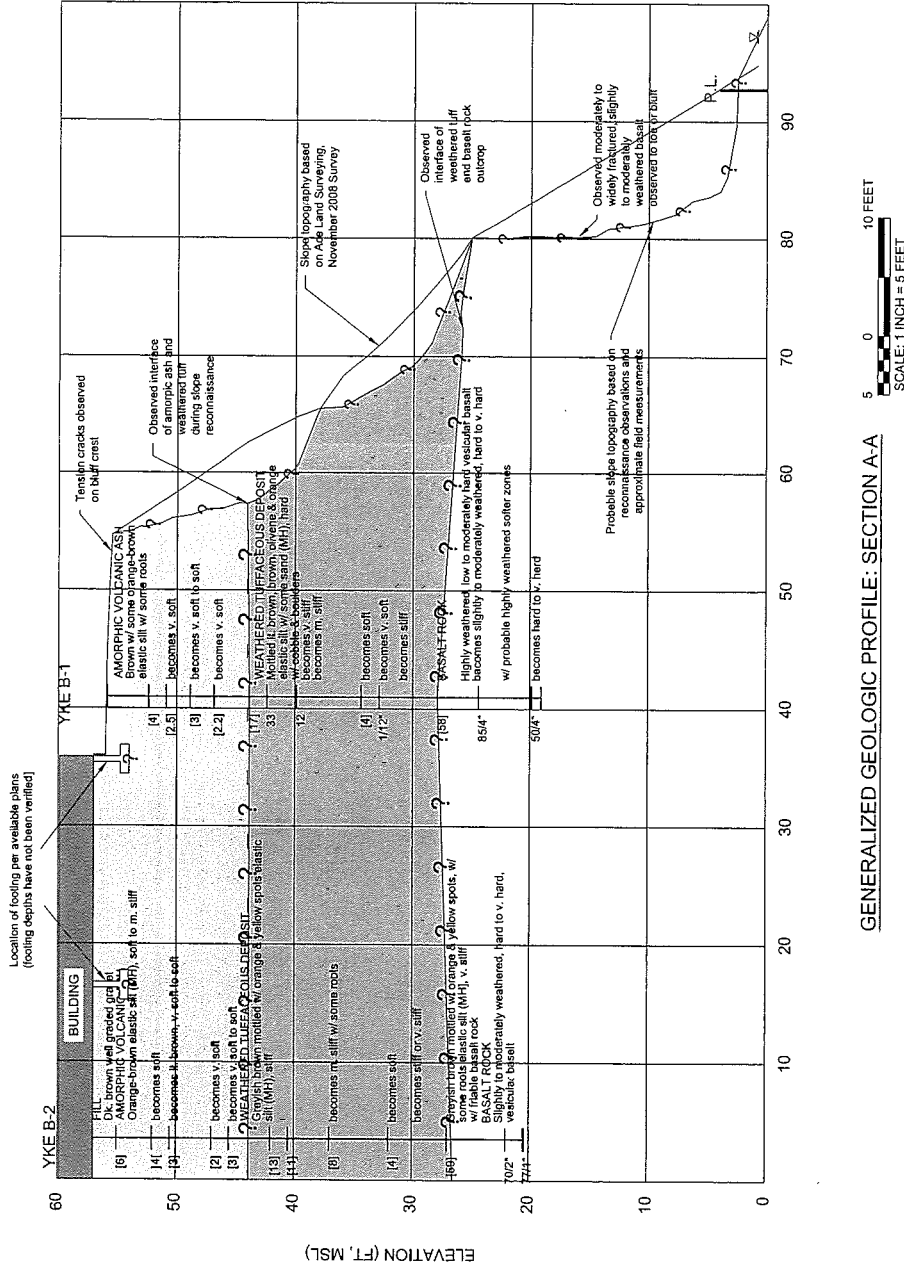
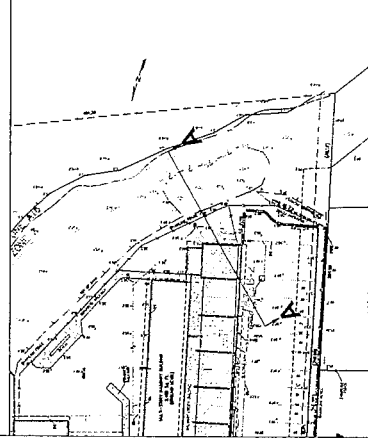
GENERALIZED GEOLOGIC PROFILE: SECTION A-A

- Rock outcrop extends from the stream bed up to an elevation of about (+/-) 28 feet. Soil-like weathered volcanic tuff (soft porous rock) and ash lies above the bedrock up to the top of the stream bank at an elevation of 55 to 56 feet. The natural soils of the very steep slopes are unstable because natural soils have limited long-term strength to support their own weight in tall and nearly vertical slope conditions. See Exhibit 2.

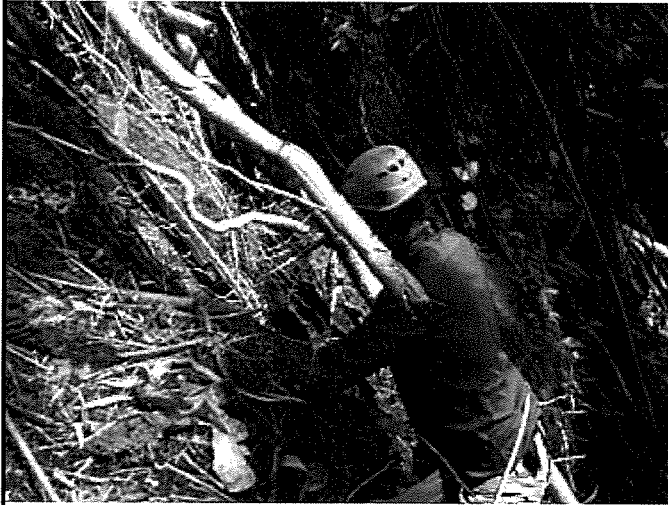
Torevane Test Performed in Exposed Ash On Upper Slope Face

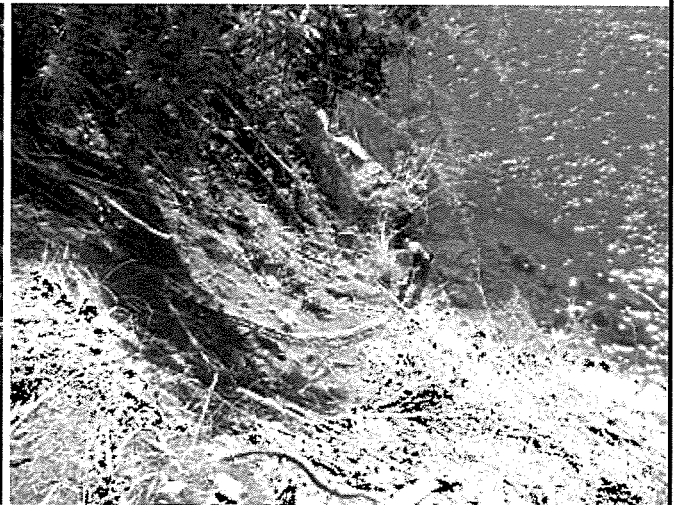
Reconnaissance Standing Near the Toe of the Slide

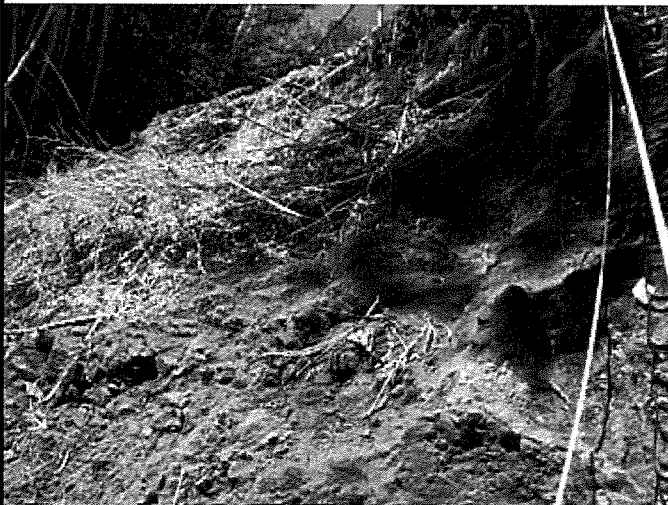
Exposed Ash Soil Along Upper Slide Face (Western End of Head Scarp)

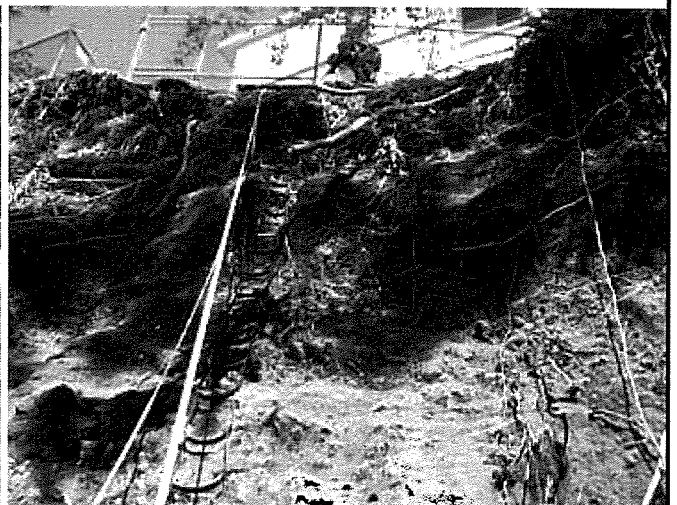
Exposed Ash Soil Along Upper Slide Face (Center of Head Scarp)

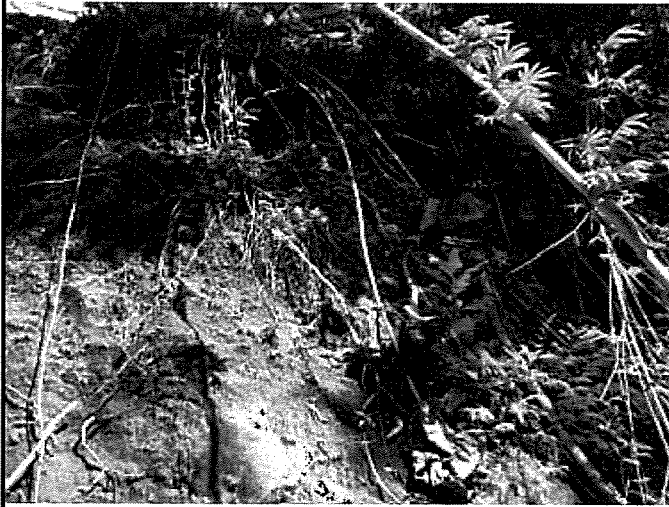
Exposed Ash Soil Along Upper Slide Face (Eastern End of Head Scarp)

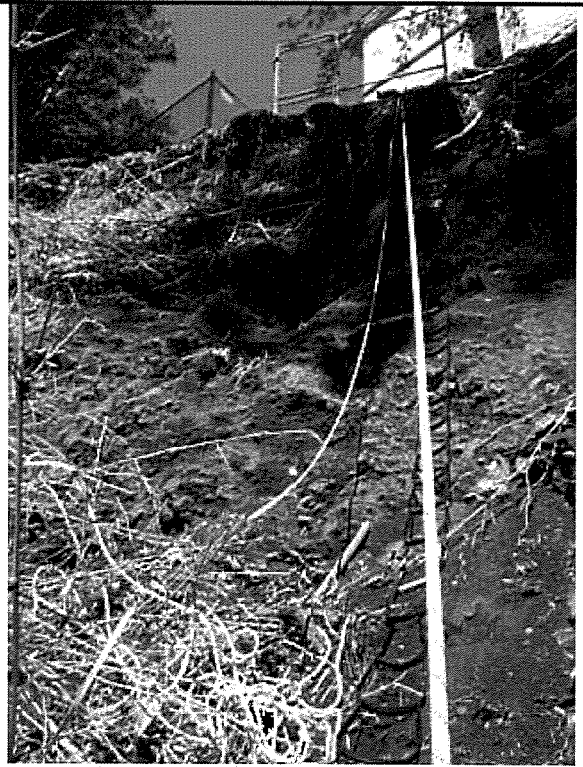
Exposed Ash Soil Along Mid to Upper Slide Face

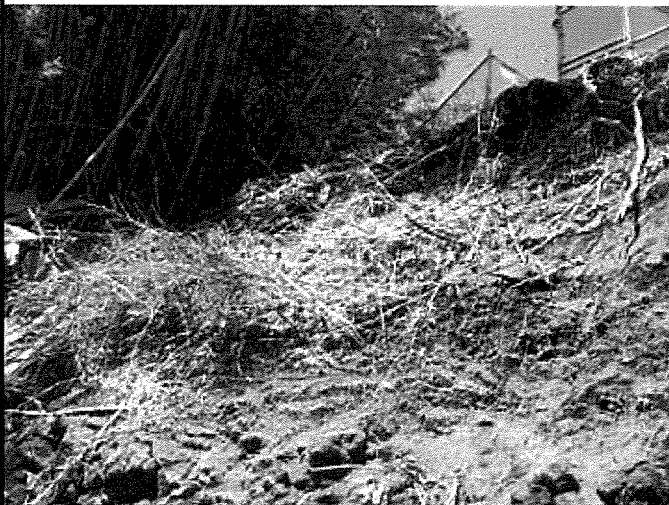
Exposed Ash Soil Along Upper Slide Face (Western Edge of Slide)

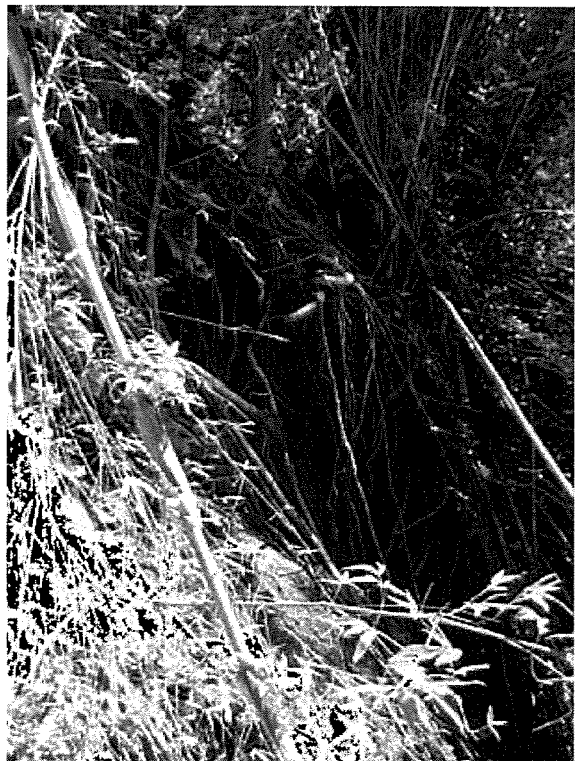
Eastern Edge of Slide Near Midslope

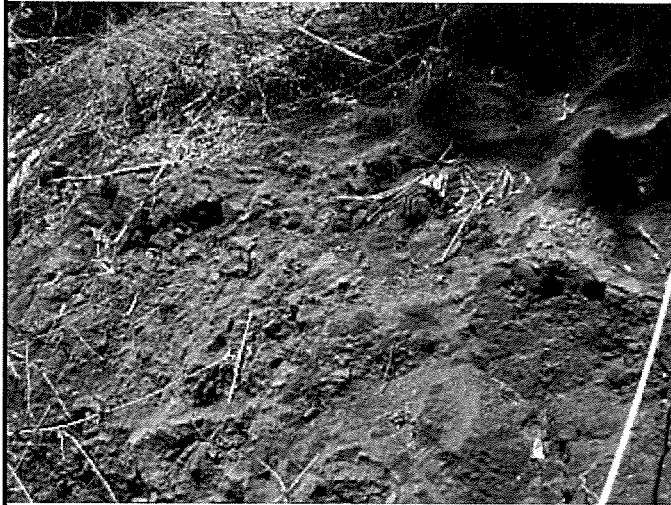
Weathered Tuff along Midslope

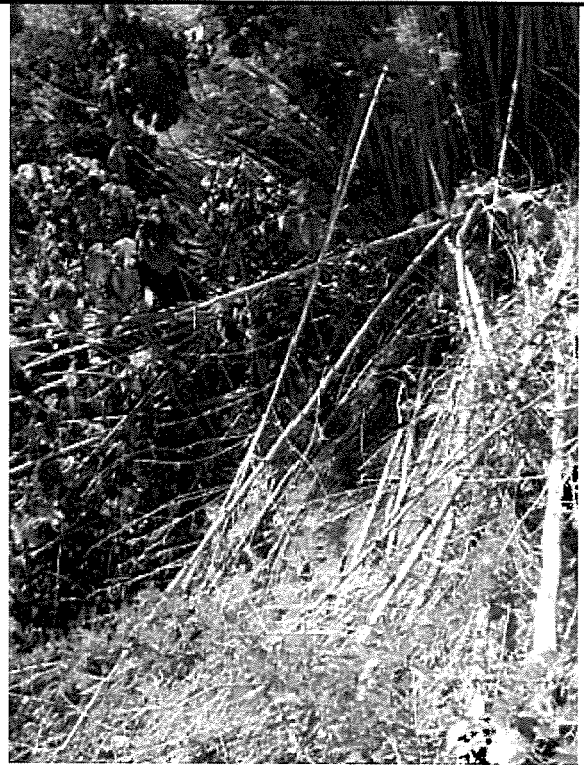
Eastern Edge of Slide Scarp (Midslope)

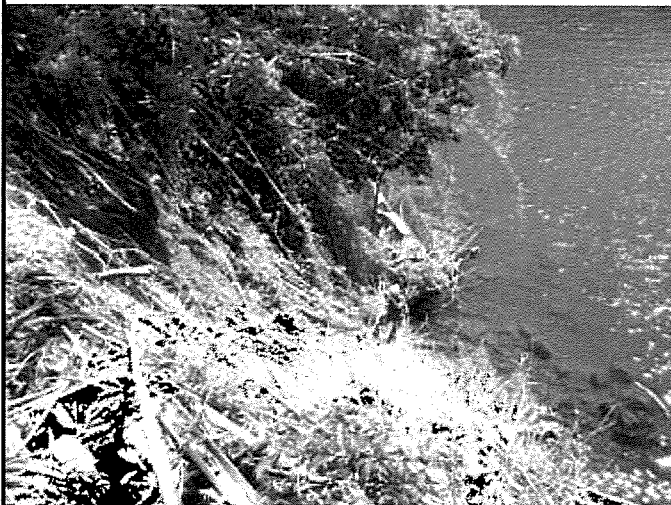
Reconnaissance Standing Near the Toe of the Slide

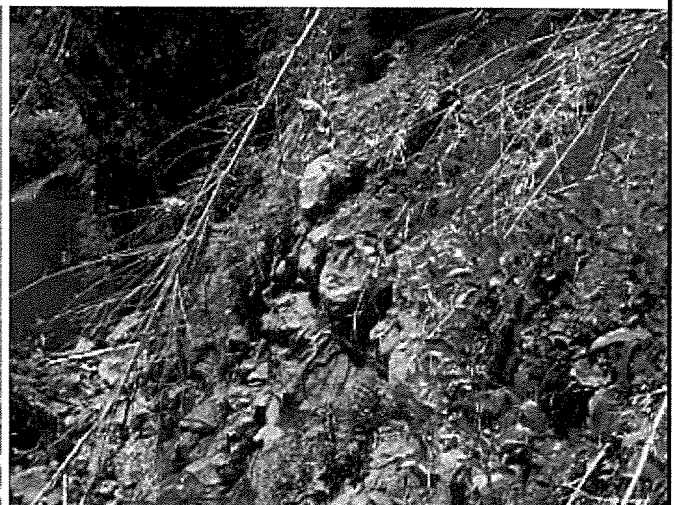
Rock Interface Observed at/below the Toe of the Slide
